FIGURE 2

Residual NAPL Thickness & **Proposed Sample Collection** Locations

Former J.H. Baxter Wood Treating Facility Arlington, Washington

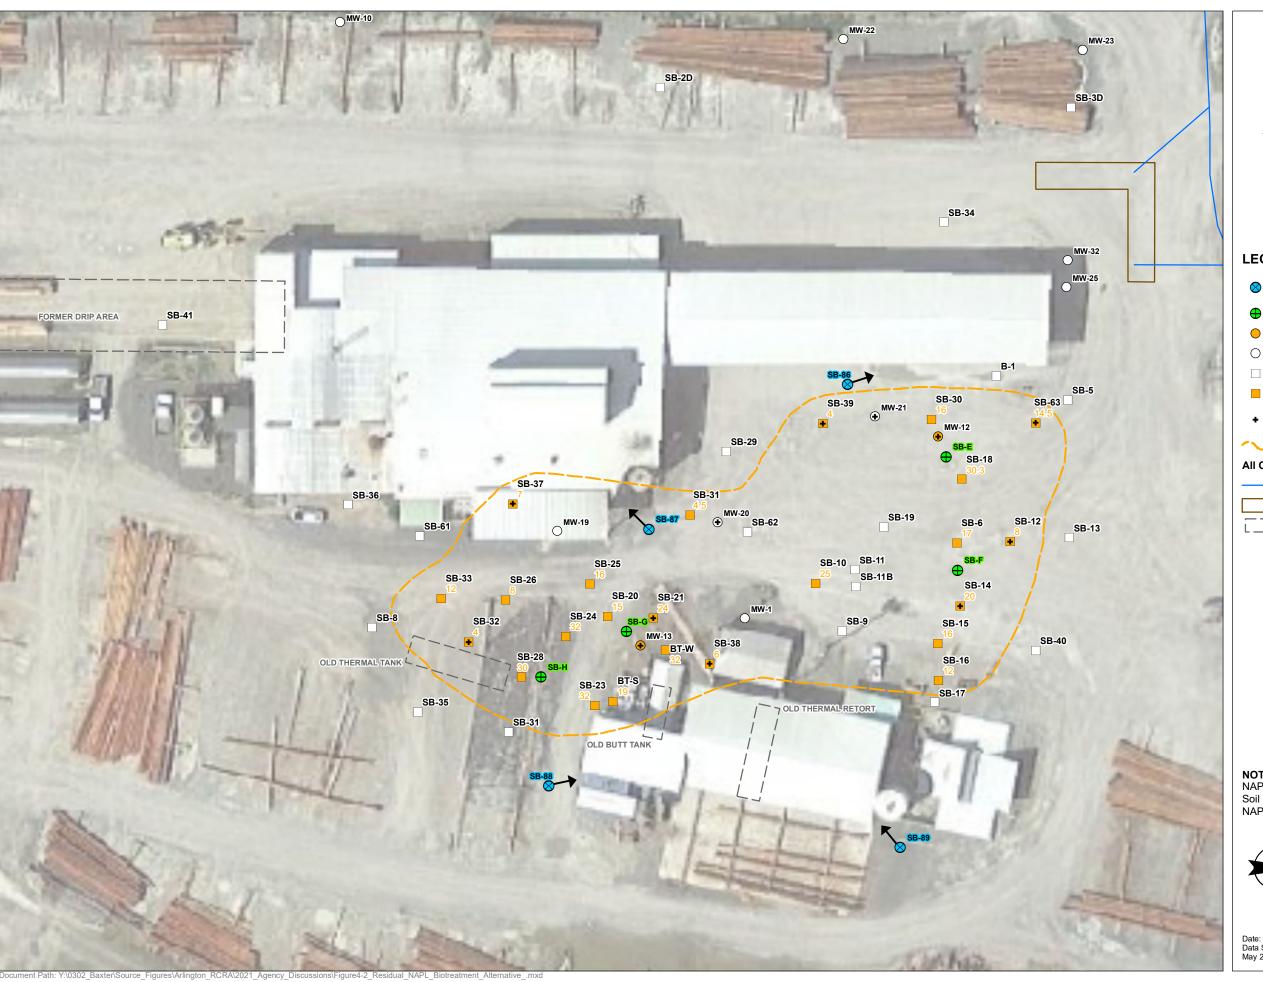
NOTE: NAPL: Nonaqueous Phase Liquid Soil Boring Location values are residual NAPL thickness in feet.
